City of Westminster

Westminster Hills Open Space

Conditions Report

Jefferson County, Colorado

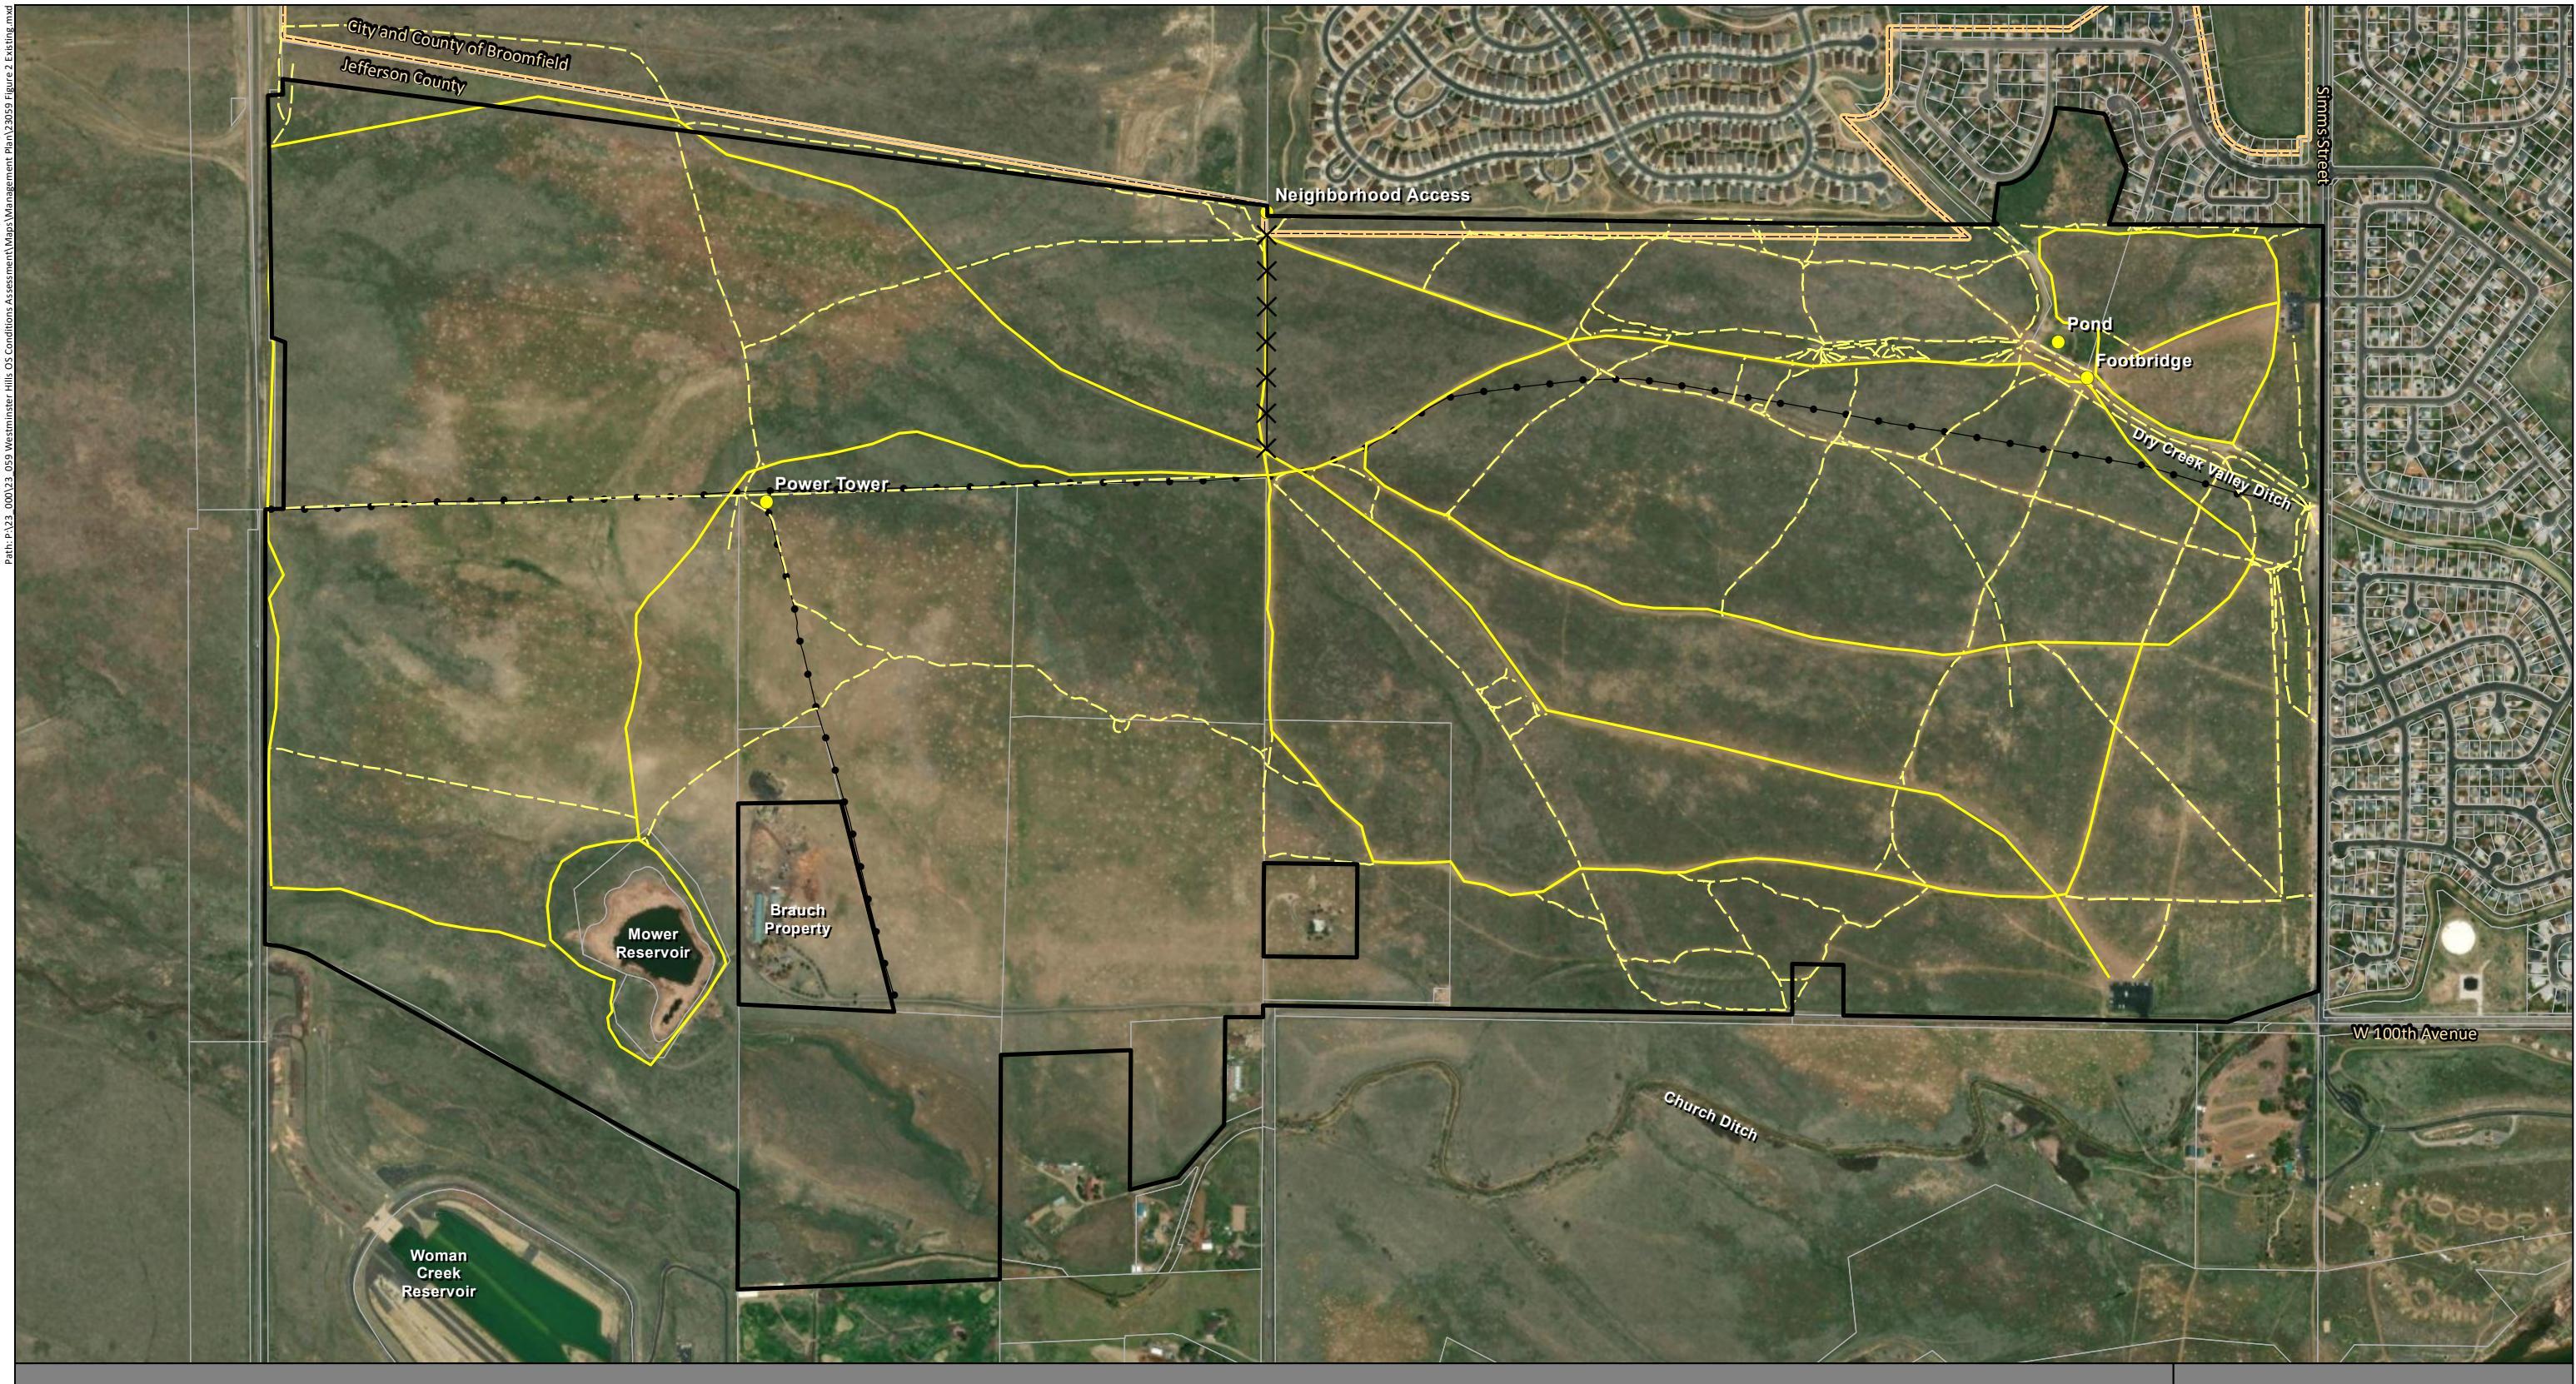
Figure 2 Existing Conditions

Project Area • Overhead Electrical Line

-- Social Trail XX Fence

– Trail

There are a significant number of social trails throughout the Property. These social trails range in severity of condition based on how frequently they are used by visitors and their location on the Property. Most social trails are concentrated on the east side of the Property, likely due to the off-leash dog park area. **Figure 2** illustrates the number of social trails on the Property.

- Continue to monitor and inventory existing designated and social trails on the Property for maintenance needs.
- Review trail network to consolidate redundant trails and consider adopting or building trails to address missing links.
